Research on the Performance of Brass Alloy Main transformer terminal

Abstract—In order to determine the material of the main transformer terminal, the electrical conductivity, mechanical properties and stress corrosion resistance of brass alloy terminal were studied by XRD, mechanical properties test and ammonia fumigation test. The results show that H59 alloy consists of (Cu,Zn) phase, Cu₅Zn₈ phase and CuZn phase, H70 alloy consists of (Cu,Zn) phase and dendritic Cu_{0.64}Zn_{0.36} phase, H80 alloy and H90 alloy are both (Cu,Zn) phase. With the increase of Cu content, the strength of brass decreases, the conductivity increases, and the stress corrosion resistance increases. H90 alloy has excellent plasticity and toughness, excellent resistance to ammonia fumigation stress corrosion, and can be used as main transformer terminal material.

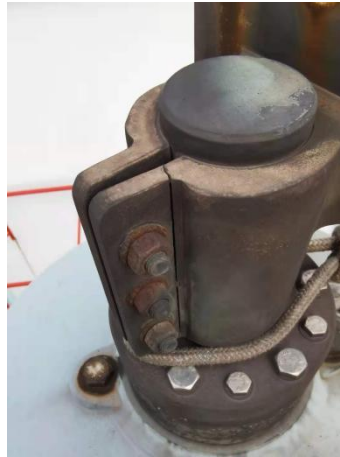
Fig.1 H59 brass alloy terminals with crack

Given the H59 terminals of the cracking phenomenon, in order to improve the using reliability of terminals, in this paper, from the perspective of terminal materials, a comparative study of brass alloy electric conductivity, mechanical properties and corrosion resistance, consolidate the foundation research for its security applications, is of great significance to solve the problem of main transformer terminal failure.

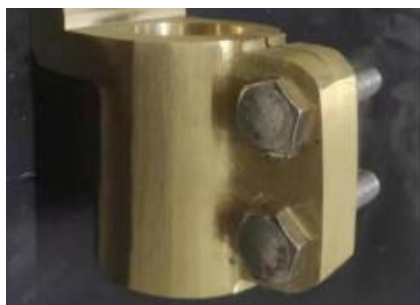
Fig.3 Bolted terminal

Stress corrosion performance of brass alloy terminals were tested under airtight container, with 14%wt. ammonia solution. The dosage of ammonia solution per liter container, total volume of not less than 166 mL per square decimeter sample surface area of not less than 100 mL, sample not touch each other and not direct contact with ammonia, according to the power system, the internal inspection brass stress ammonia smoked method, The test time was set at 24 hours. The objects of ammonia fumigation are bolted terminals. After ammonia fumigation, the corrosion products were removed with

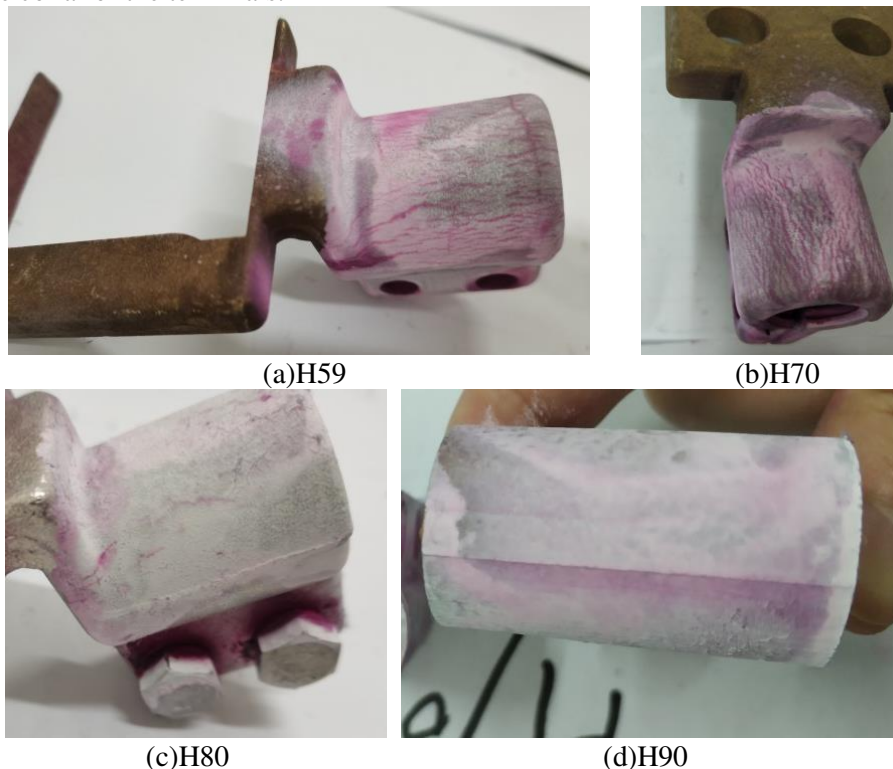
Fig. 5 shows the surface morphology of ammonia fumigating terminal for colored flaw detection. It can be found that H59, H70 and H80 terminals all have significant cracking characteristics on the outer surface of the collar of the terminals.

Fig.5 Surface morphology of ammonia fumigating terminal

With increasing Cu content, terminal clamp under the surface cracking characteristics gradually reduce, when Cu content increased to 80%, H80 terminal clamp under the surface rendering the capillaries of the initiation of crack characteristics, no significant crack phenomenon, when Cu content increased to 90%, while the H90 terminal clamp under the surface corrosion crack characteristics disappear. As brass with less than 15% Zn has corrosion resistance completely similar to red copper in various corrosive media, brass with more than 15% Zn, especially (Cu,Zn)+CuZn brass, has prominent stress corrosion problems^[5]. Therefore, the material of the terminal is H90, which has good application reliability.
